# SERVICE BULLETIN

AMClassification: BT04-051	Reference: NTB05-017	Date: February 24, 2005
-------------------------------	-------------------------	----------------------------

## 2004 TITAN /ARMADA; FRONT LH/RH WINDOWS - RATTLE NOISE WHEN PARTIALLY OPENED

**APPLIED VEHICLE(S):** 2004 Titan (A60),  
2004 Armada (TA60)

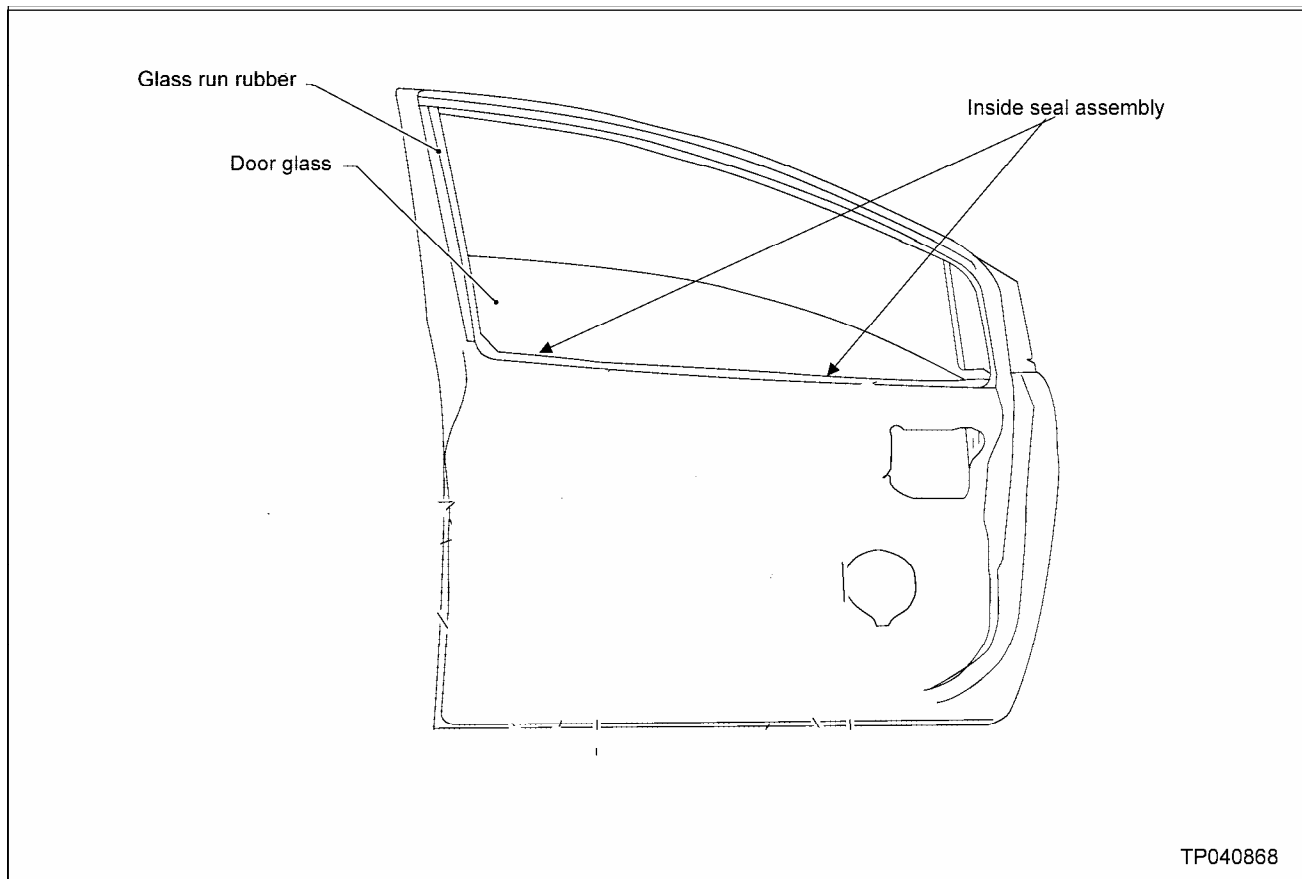
Figure 1

A ticking noise at the front LH and/or front RH window

- with the window partially rolled down
  - over rough/uneven roads or when the the door is closed
- and
- holding the glass stationary under the same condtions eliminates the noise.

1. Remove the front door panel, as described/shown in the Service Manual Section EI.
2. Remove the front glass assembly, as described/shown in the Service Manual Section GW. (Figure 1)

3. Remove the glass run rubber assembly from the door (Figure 1).
  - Replace it with the glass run rubber assembly from the Parts Information section of this bulletin.
  - Make sure the glass run rubber assembly is installed correctly into the metal channels.
4. Re-install the door glass assembly.
  - Make sure glass fits properly into the run rubbers.
  - Perform all inspections and operations as shown in the GW Sections, including setting of the Limit Switch.
5. Reassemble the front door in the reverse order, replacing the old Inside seal assembly with the Inside seal assembly from the Parts Information section of this bulletin. (Figure 1)
