SERVICE BULLETIN

Classification: RS03-008a	Reference: NTB04-003a	Date: March 17, 2004
------------------------------	--------------------------	-------------------------

2004 TITAN AND ARMADA; AIR BAG LIGHT ON CODE B1023 STORED

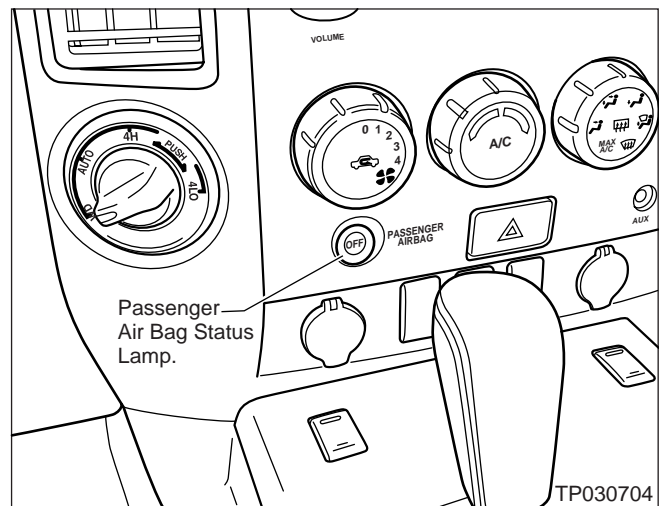
Figure 1

- The "AIR BAG" warning light is ON, **with**
- DTC "Passenger Air Bag Indicator Circuit" (B1023) stored, **and/or**
- The PASSENGER AIRBAG "Status Lamp" (see Figure 1) does not come ON (it's inoperative),

- Replace the Status Lamp with the new one listed in the Parts Information.
