# SERVICE BULLETIN

Classification: EC04-013a	Reference: NTB04-124a	Date March 21, 2005
------------------------------	--------------------------	------------------------

## 2004 TITAN AND ARMADA; KNOCKING NOISE FROM ENGINE AREA

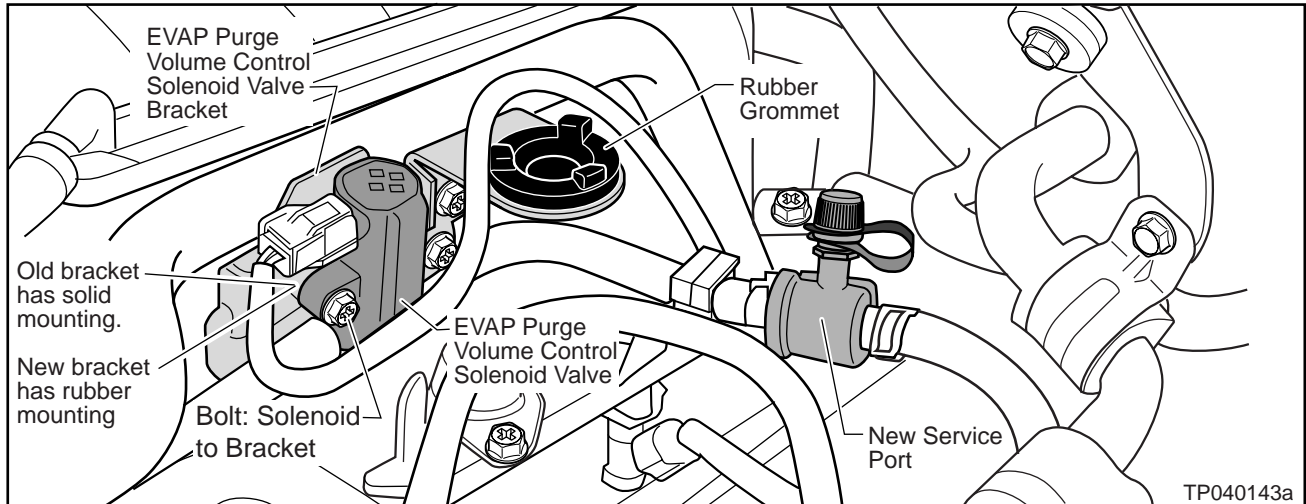
Figure 1

The noise is coming from the EVAP canister purge volume control solenoid valve and piping (see steps 1 – 6 in the Service Procedure).

7. Remove the engine cover and replace the following parts (see Figures 1 and 2):

- EVAP canister purge volume control solenoid valve bracket.
- Bolts that hold the solenoid valve to the bracket.
- Service port.

- Use the new parts listed in the Parts Information.
- Make sure you move the rubber grommet and solenoid valve from the old bracket to the new bracket (see Figure 1).
- Make sure you install the Service Port in the correct direction (see Figure 2).

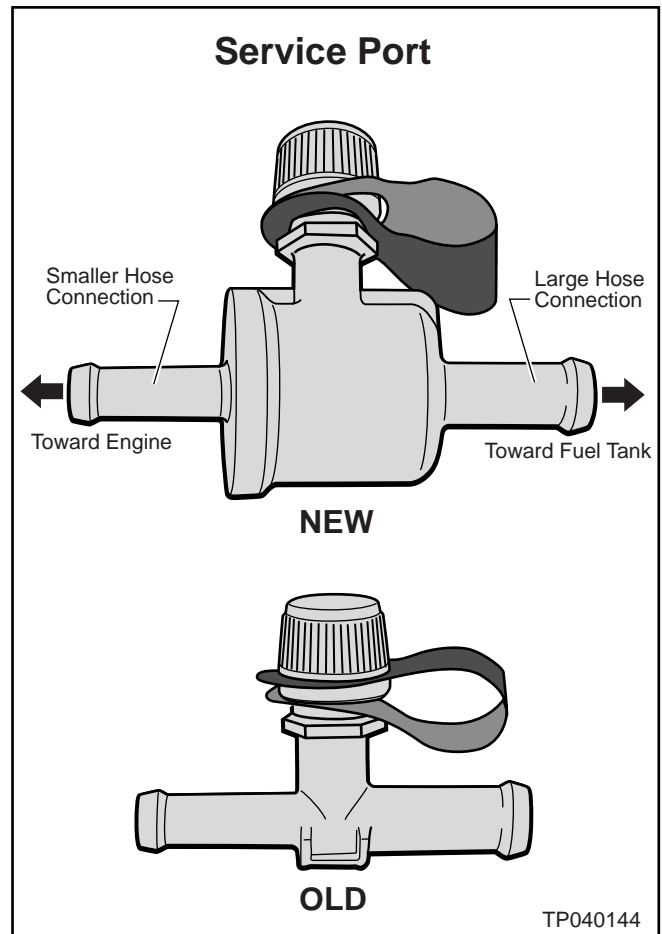
Figure 2

**NOTE:** If your vehicle already has the “new” style service port, this bulletin does not apply (see Figure 2).
