SERVICE BULLETIN

Classification: EL04-031	Reference: NTB04-131	Date: November 22, 2004
-----------------------------	-------------------------	----------------------------

2004 ARMADA AND TITAN: ENGINE WILL NOT CRANK AND/OR START AND/OR TRANSMISSION IMPROPER OPERATION

APPLIED VEHICLES: 2004 Armada (TA60)
2004 Titan (A60)

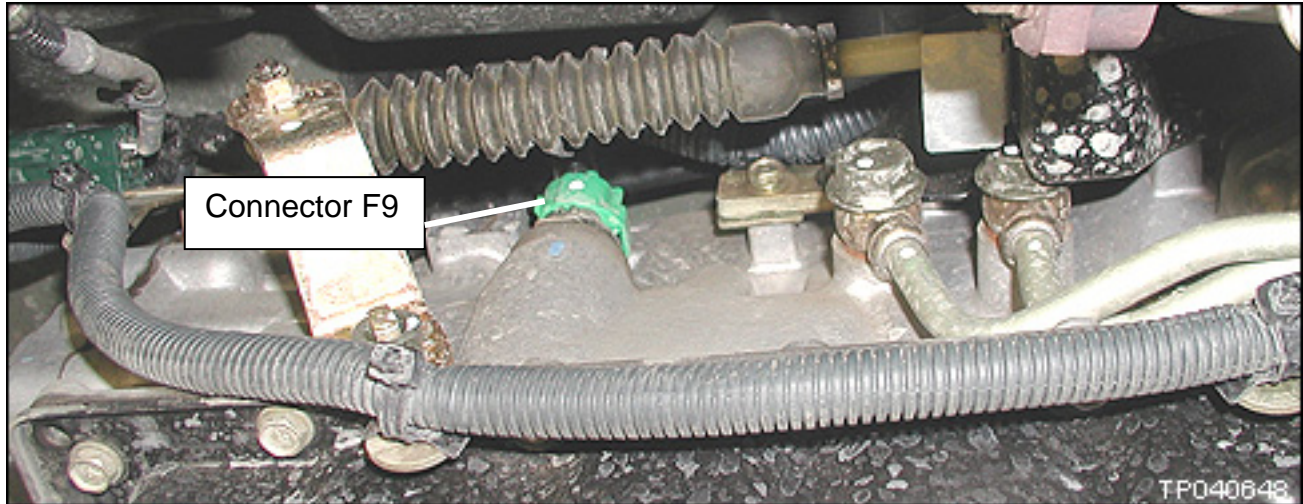
Figure 1

Connector F9 has water or corrosion.

1. Disconnect connector F9 (see Figure 1).

- Connector F9 is located on the right side (passenger side) of the transmission.
