SERVICE BULLETIN

EL04-020

September 7, 2004

2004 TITAN AND ARMADA; REAR SONAR BEEPS CONTINUOUSLY

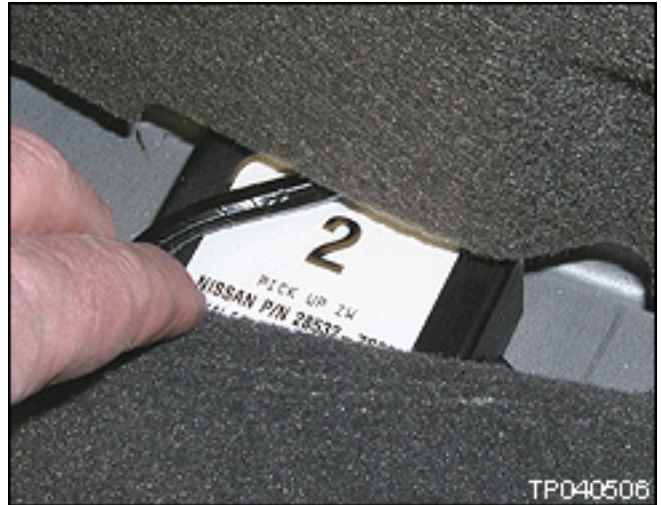
Figure 1

1. Fold DOWN the left side (driver's side) rear seat back.
2. Pull the floor carpet away from the rear of the cabin so you can see the Sonar Control Unit (see Figure 1).
3. You should see the number **2**.
 - If you see any other number, Replace the Sonar Control Unit.
 - Go to Section DI of the appropriate Service Manual for control unit replacement instructions.

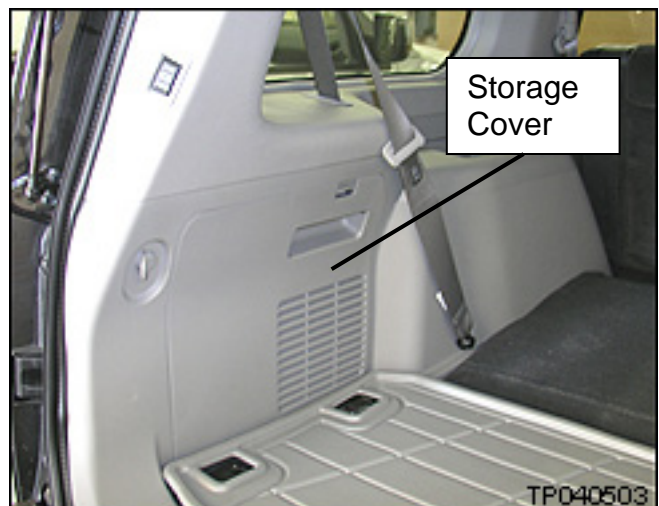
Figure 2

1. Remove the left rear storage cover.

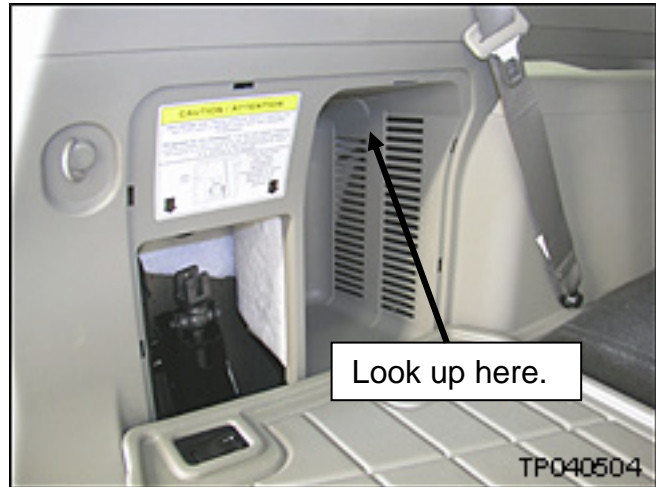
Figure 3

2. Look up through the slits in the storage area (see Figures 3 and 4)

- You can see the sonar control unit through the slits.

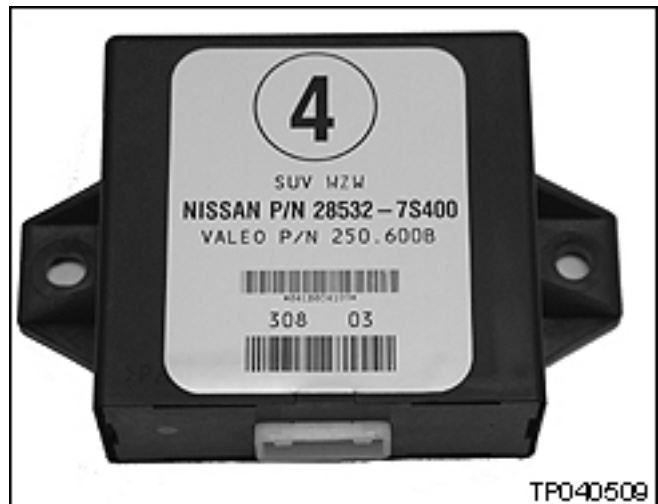
Figure 5

3. Looking through the slits, you will be able to see a number on the control unit.

- You should see the number **4**
- If you see any other number, Replace the Sonar Control Unit.
- Go to Section DI of the appropriate Service Manual for control unit replacement instructions.

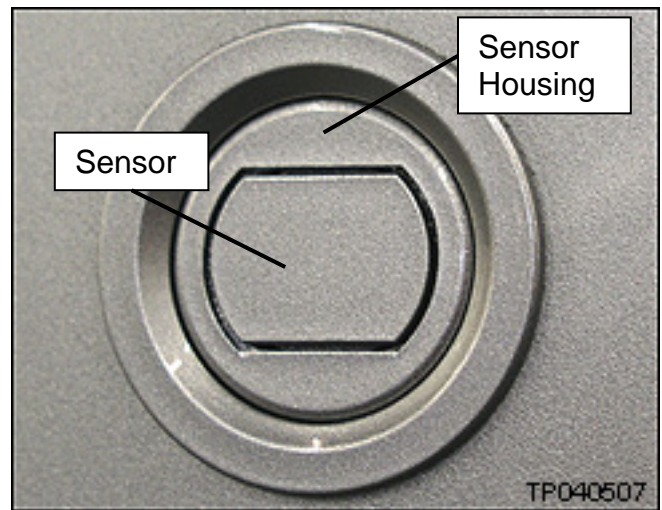
1. Check each of the 4 sensors in the rear bumper.

2. The sensor should be even with or just above the sensor housing (see Figure 6 and 7).

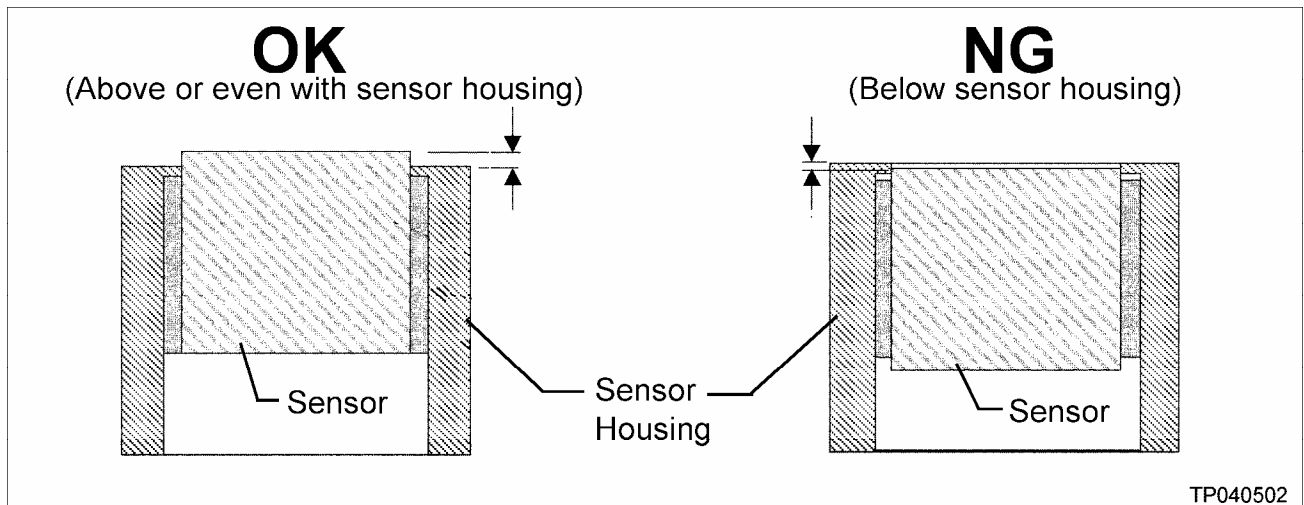
Figure 7

- If any sensor is below the sensor housing as shown in Figure 7, replace it.
- Go to Section DI of the appropriate Service Manual for Sensor replacement instructions.
