SERVICE BULLETIN

| Classification: EC04-016a | Reference: NTB04-056a | Date: August 3, 2004 |

2004 TITAN & ARMADA; MIL "ON" WITH DTC P1278, P1279, P1288, P1289 A/F SENSOR

APPLIED VEHICLES: 2004 Titan (A60)
2004 Armada (TA60)

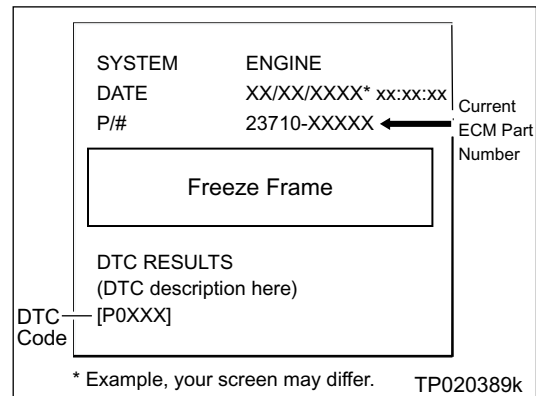
- Figure 1 is an example of the F.F. Data printout.
- The Freeze Frame data that you’ve printed contains the ECM Part Number (P/N).
- The ECM part number will be used to see if this bulletin applies or not.

3. Check the ECM Part Number on the printout from Step 1 (Figure 1);
 - Compare your vehicle's ECM P/N to those shown under **Current ECM P/N** in **Chart A**, below:
 - If it's in that column, this bulletin applies.

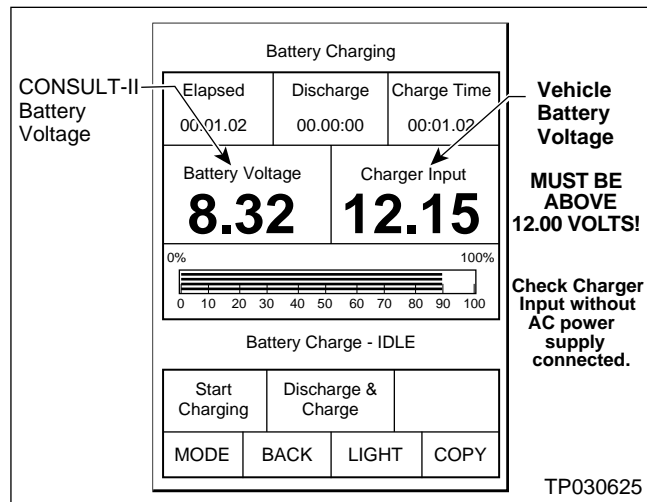
Figure D

- "Battery Voltage" is the voltage level of CONSULT-II's battery.
- "Charger Input" is the voltage level of the vehicle's battery. **(It must be above 12 volts.)**

3. Check the CONSULT-II's "Charger Input" reading (see Figure D).

CAUTION: If the "Charger Input" is below 12 volts:
