# RECALL CAMPAIGN BULLETIN

NTB04-086

## 2004 NISSAN TITAN; UPPER INTERIOR OCCUPANT PROTECTION VOLUNTARY SAFETY RECALL CAMPAIGN

**CAMPAIGN I.D. # / NHTSA #:** R0406 / 04V-345

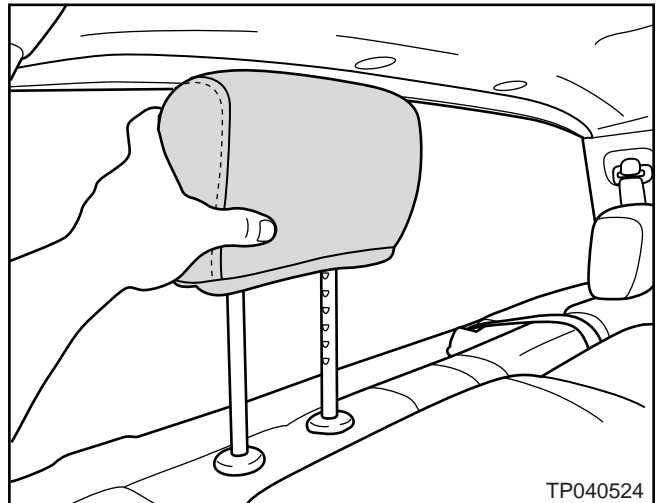
Figure 1

3. Remove the head restraints from both the left & right rear seats.

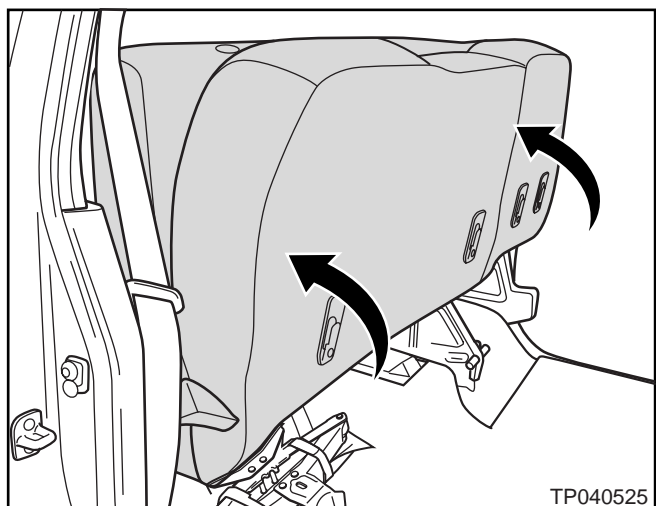
Figure 2

4. Fold UP both the left & right rear seat bottoms.

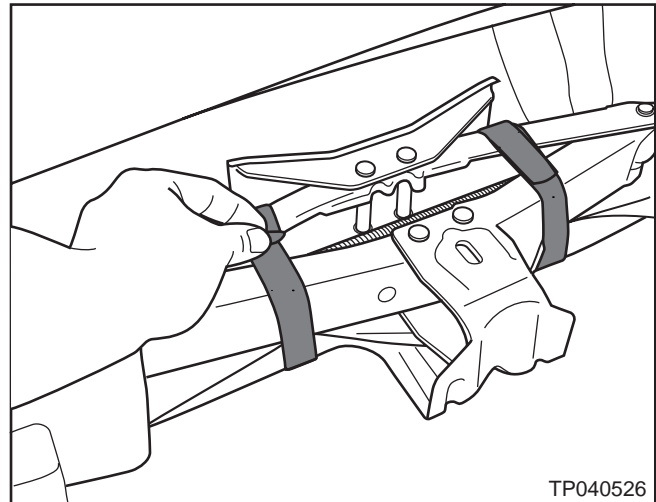
Figure 3

5. Remove the jack and tool kit.
  - Carefully store them out of the way.

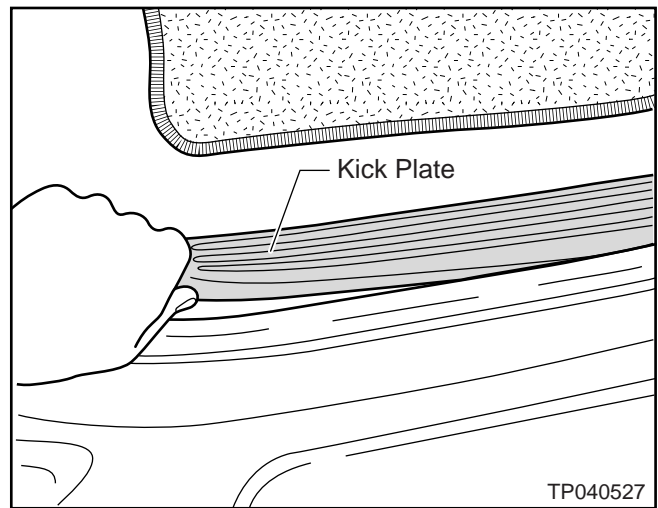
Figure 4

6. Remove the kick plates from the left & right rear doors.
  - Carefully store them out of the way so they won't get damaged.

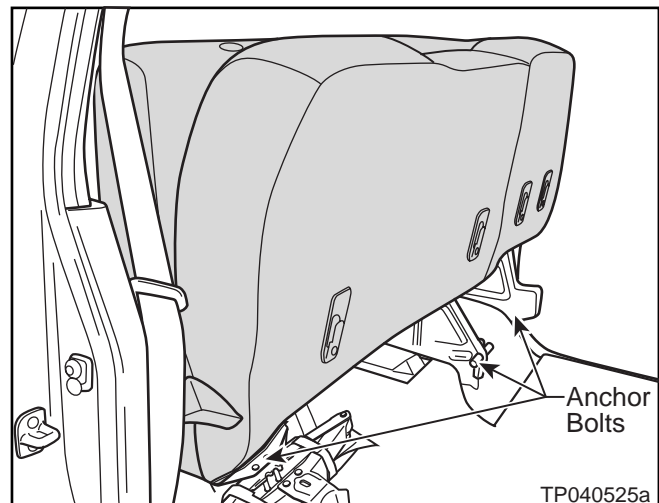
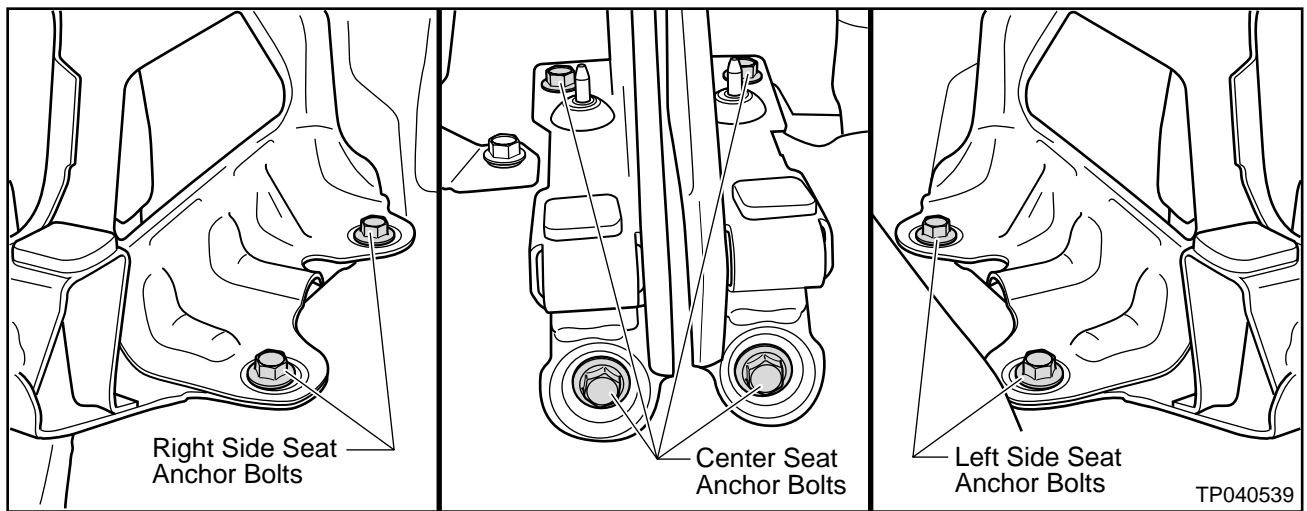
7. Remove the 8, 14mm, rear seat anchor bolts (see Figure 5 and 6).

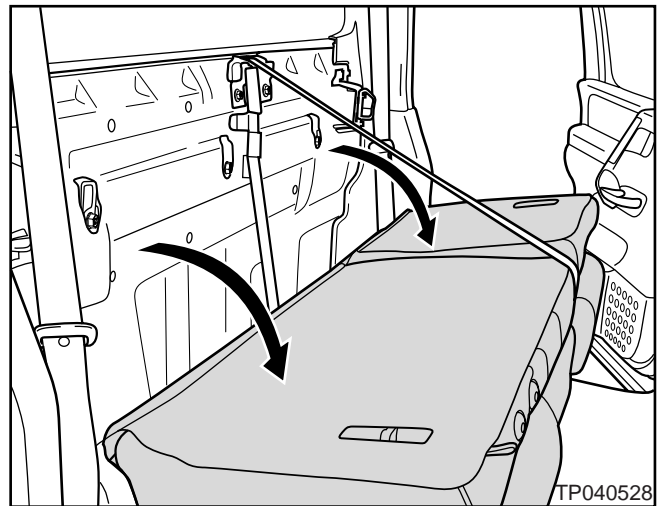
Figure 7

8. Fold DOWN the rear seat bottoms and seat backs.

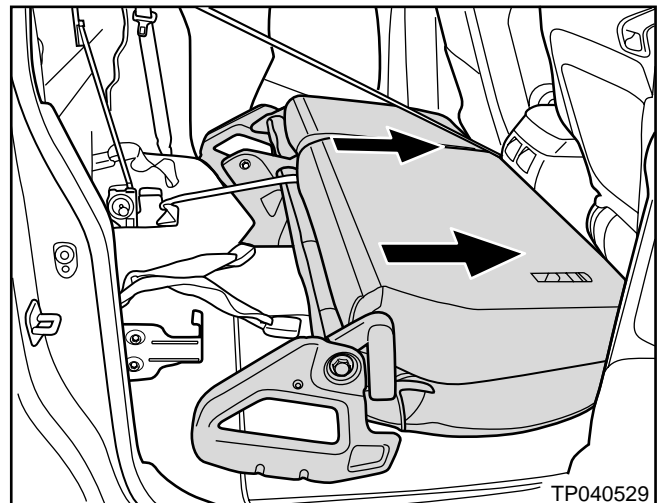
Figure 8

9. Move the seat forward.
10. Pull the seat belt buckles out of the seat.

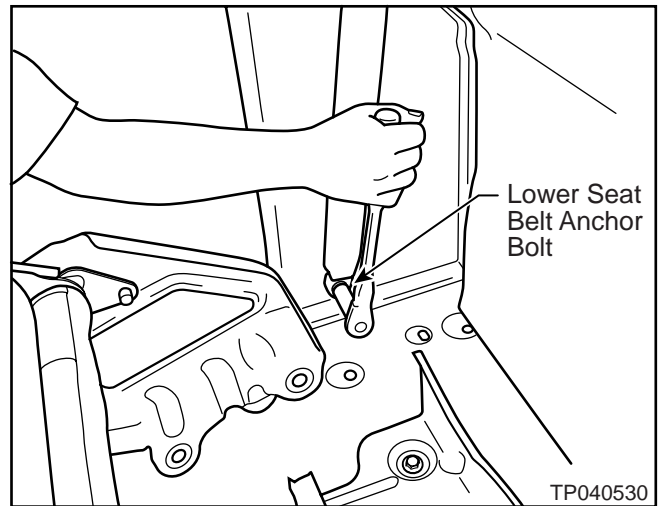
Figure 9

11. Remove the 14mm lower seat belt anchor bolt.

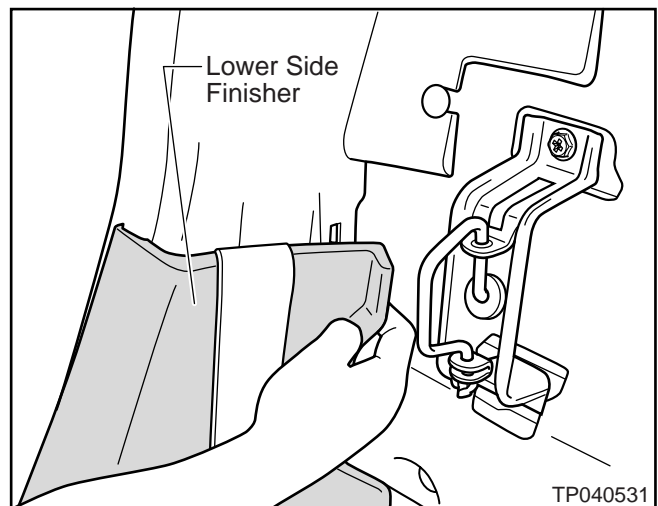
Figure 10

12. Remove the lower side finisher.

- Carefully store them out of the way so it won't get damaged.

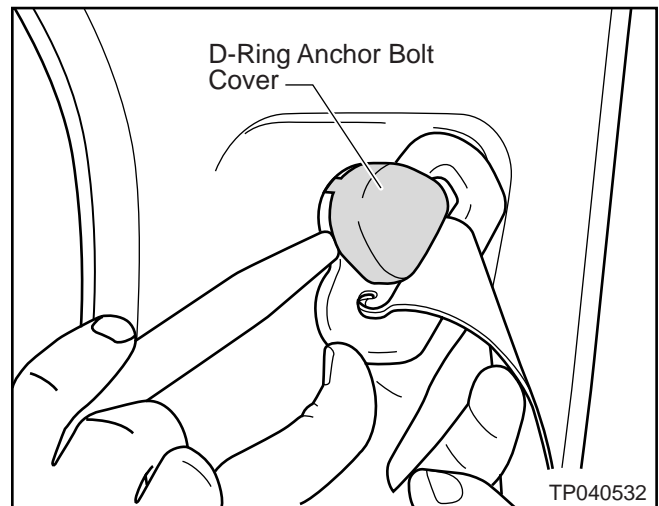
Figure 11

13. Remove the D-Ring anchor bolt cover and throw it away. It won't be reused.

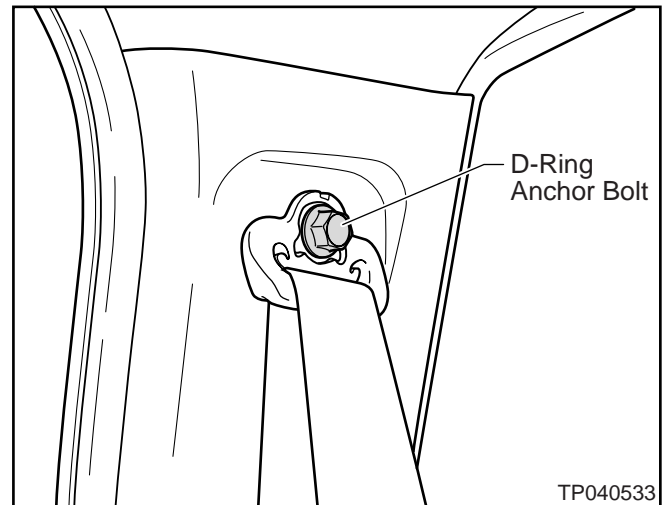
Figure 12

14. Remove the 14mm D-Ring anchor bolt.

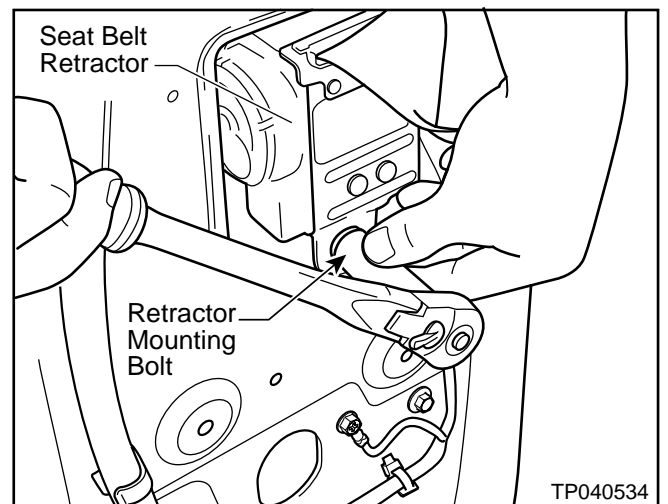
Figure 13

15. Remove the 14mm seat belt retractor mounting bolt, then remove the seat belt tough assembly from the vehicle.

**IMPORTANT: Cut the seat belt strap to make the old seat belt unusable.**

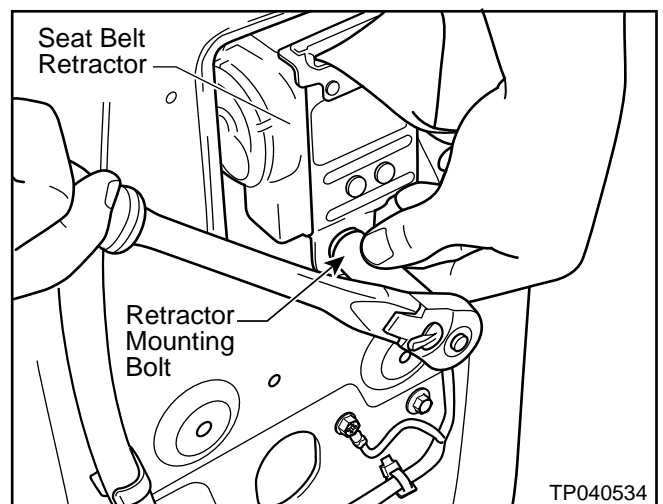
Figure 14

**NOTE:** The retractor must be in the vertical mounting position before you can pull out (extend) the belt. If the retractor is not in the vertical mounting position, the belt will easily lock up when you pull on it.

16. Install retractor and mounting bolt.

**Torque Spec.: 55.85 N.m (5.7 kg-m, 41 ft-lb)**

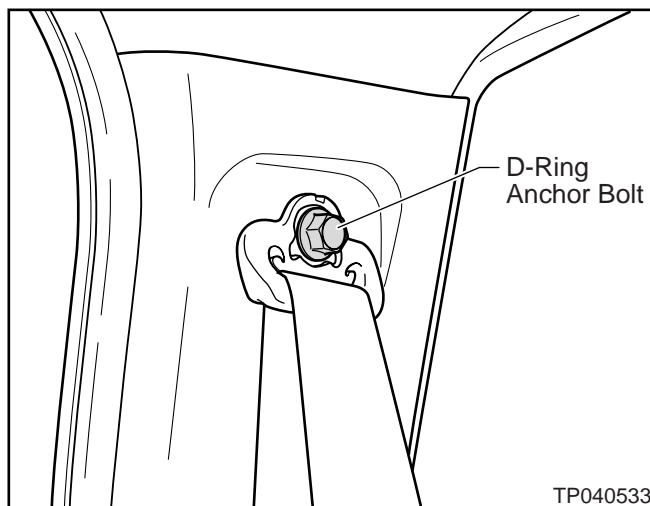
Figure 15

17. Install the 14mm D-Ring anchor bolt.

**Torque Spec.: 55.85 N.m (5.7 kg-m, 41 ft-lb)**

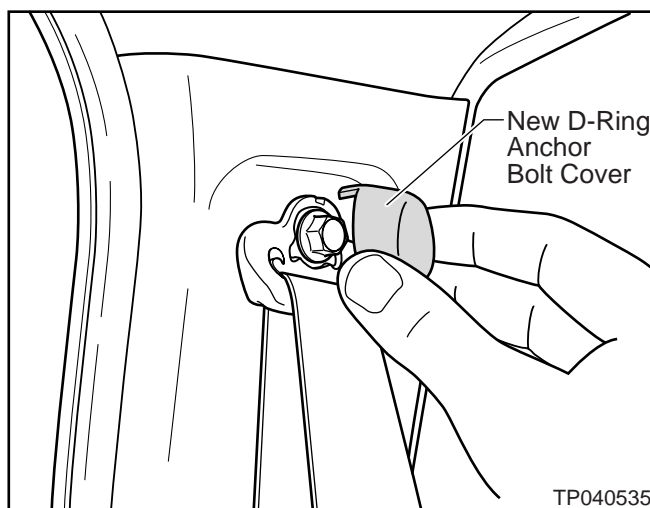
Figure 16

18. Attach the new D-Ring anchor bolt cover supplied with the service kit.

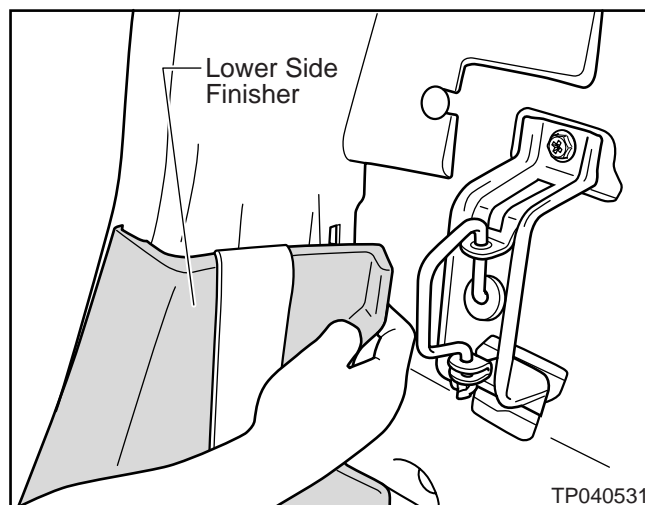
Figure 17

19. Install the lower side finisher.

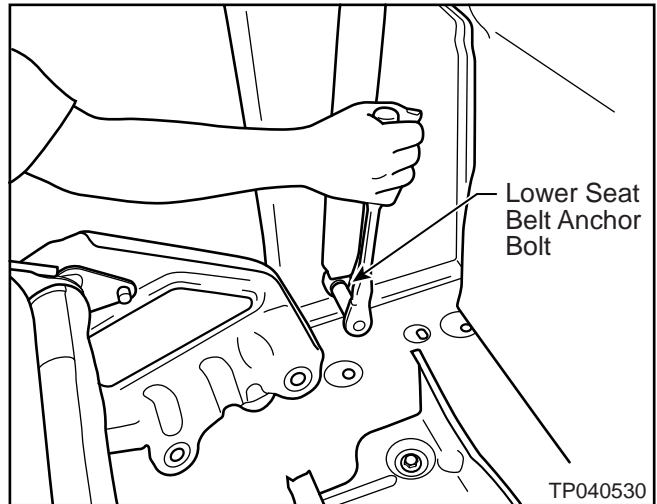
Figure 18

20. Install the 14mm lower seat belt anchor bolt.

**Torque Spec.: 55.85 N.m (5.7 kg-m, 41 ft-lb)**

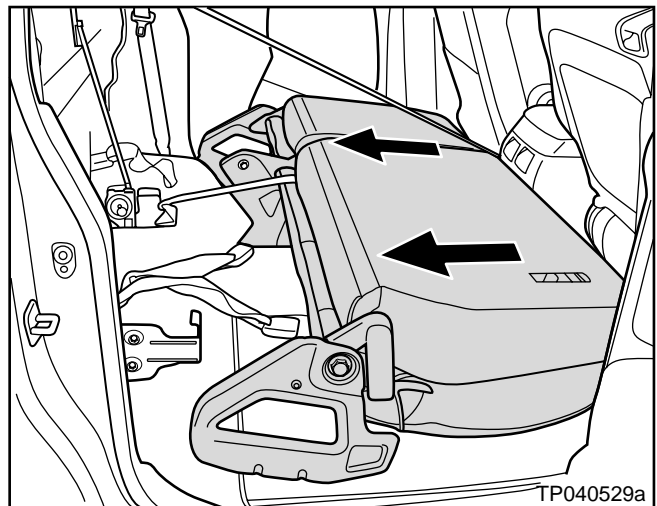
Figure 19

21. Move the seat back into it's mounting position.

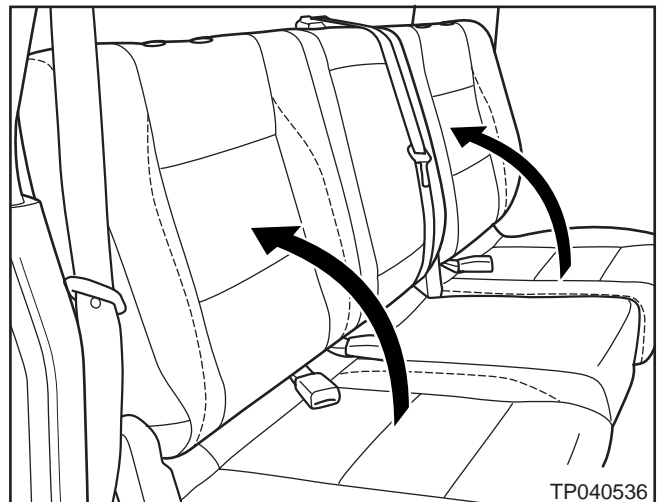
Figure 20

22. Fold UP the rear seat backs and latch them into position.

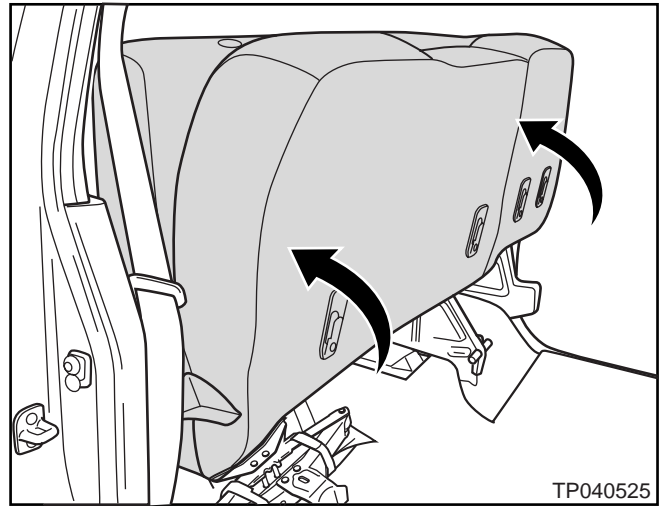
Figure 21

23. Fold UP the rear seat bottoms.

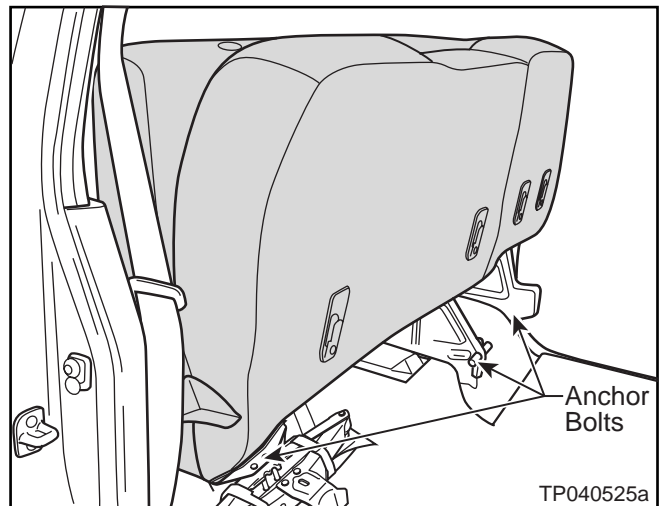
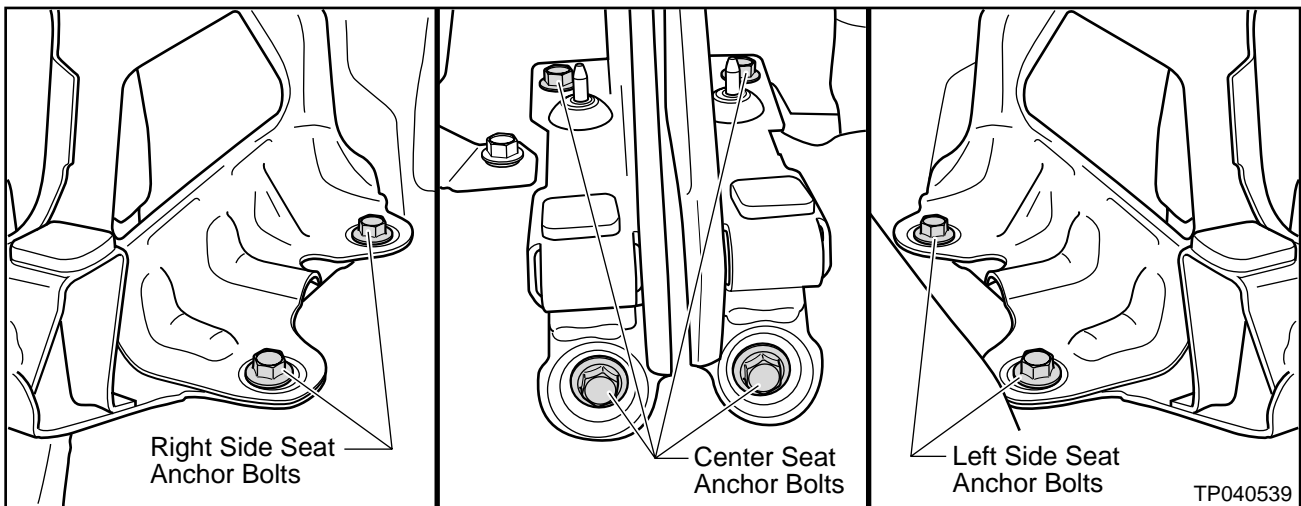
Figure 22

24. Install the 8, 14mm, seat anchor bolts (see Figures 22 and 23).

**Torque Spec.: 41-52 N.m  
(4.1-5.3 kg-m, 30-38 ft-lb)**

**IMPORTANT:** Make sure both locating pins are in the correct position.

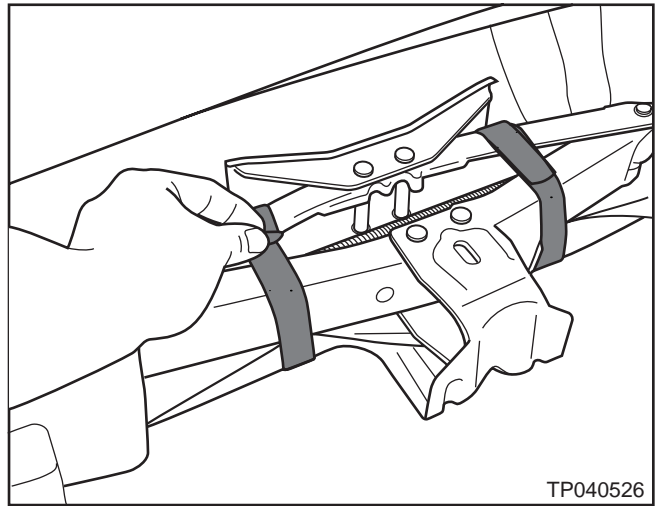
Figure 24

25. Reinstall the jack and tool kit.

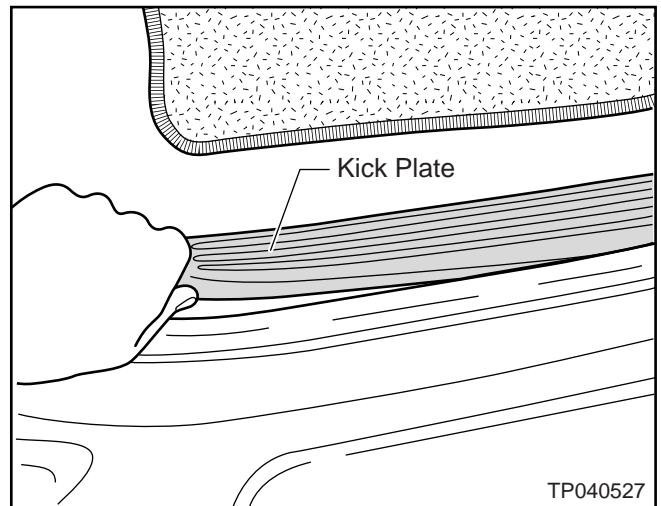
Figure 25

26. Reinstall the kick plates—both sides.

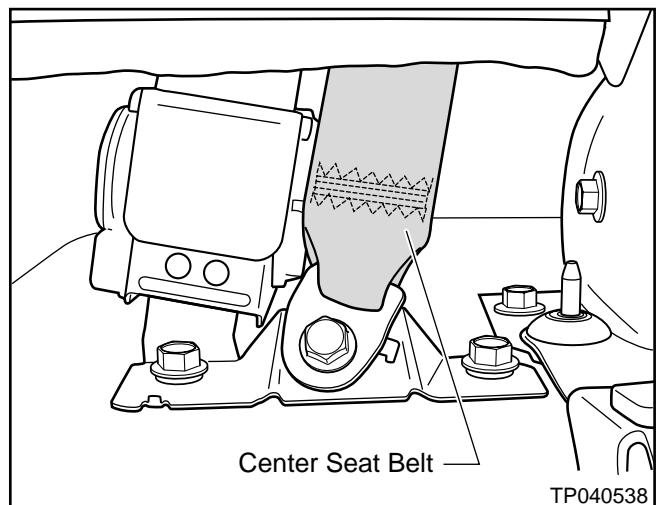
Figure 26

27. Make sure the center seat belt is positioned under the seat as shown in Figure 26.

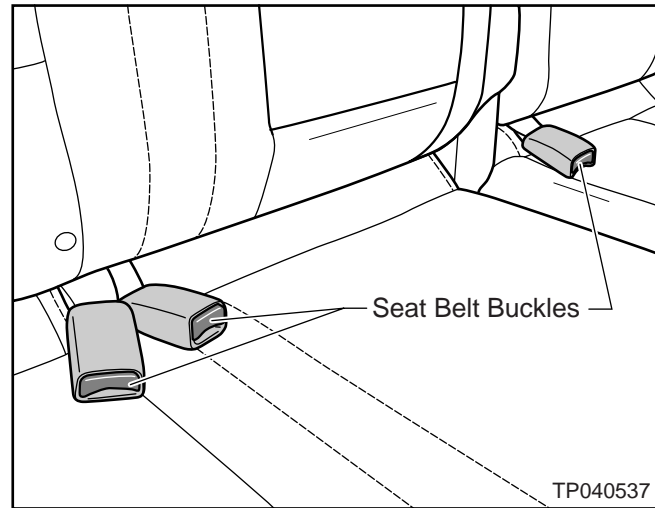
Figure 27

- 28. Fold DOWN the rear seat bottoms.
- 29. Put the seat belt buckles back into the seat.
