SERVICE BULLETIN

2004 TITAN AND ARMADA; MIL "ON" WITH DTC P1031, P1051, P1148, P1168 A/F SENSOR HEATER / CLOSED LOOP

APPLIED VEHICLES: 2004 Titan (A60)
2004 Armada (TA60)

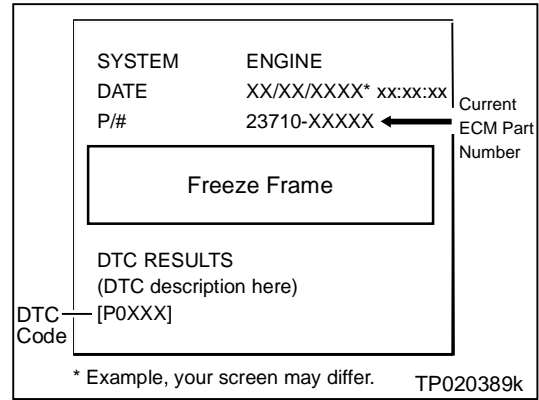
- Figure 1 is an example of the F.F. Data printout.
- The Freeze Frame data that you've printed contains the ECM Part Number (P/N).
- The ECM part number will be used to see if this bulletin applies or not.

3. Check the ECM Part Number on the printout from Step 1 (Figure 1);

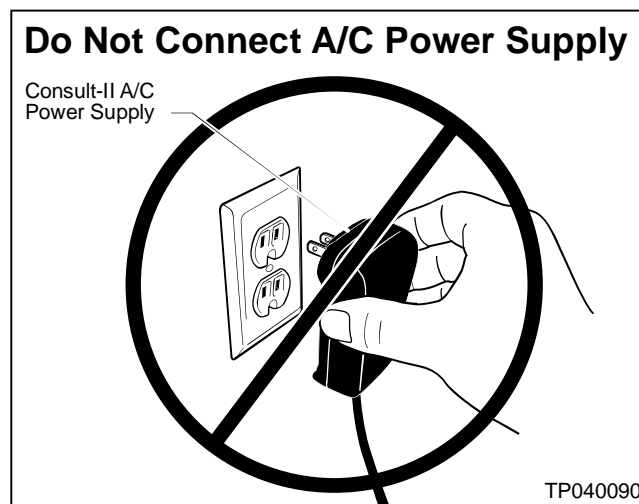
Figure B

CAUTION: For steps 2 and 3 on the next page, DO NOT connect the CONSULT-II A/C Power Supply (see Figure B).

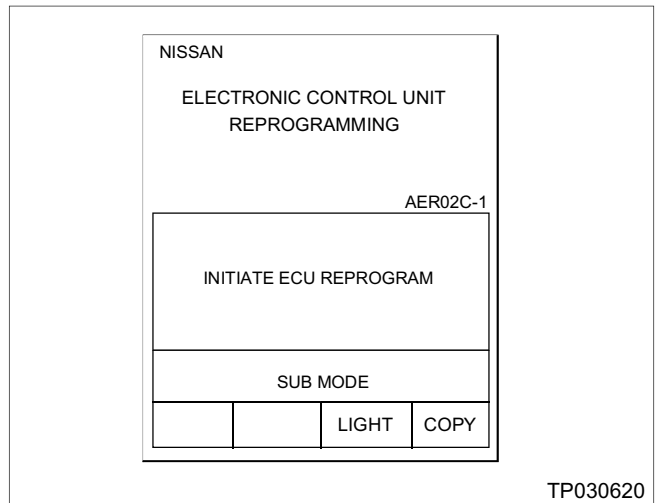
Figure C

2. Press **SUB MODE** (see Figure C) then:
 - a. From the listed items, find and select **BATTERY CHARGE**.

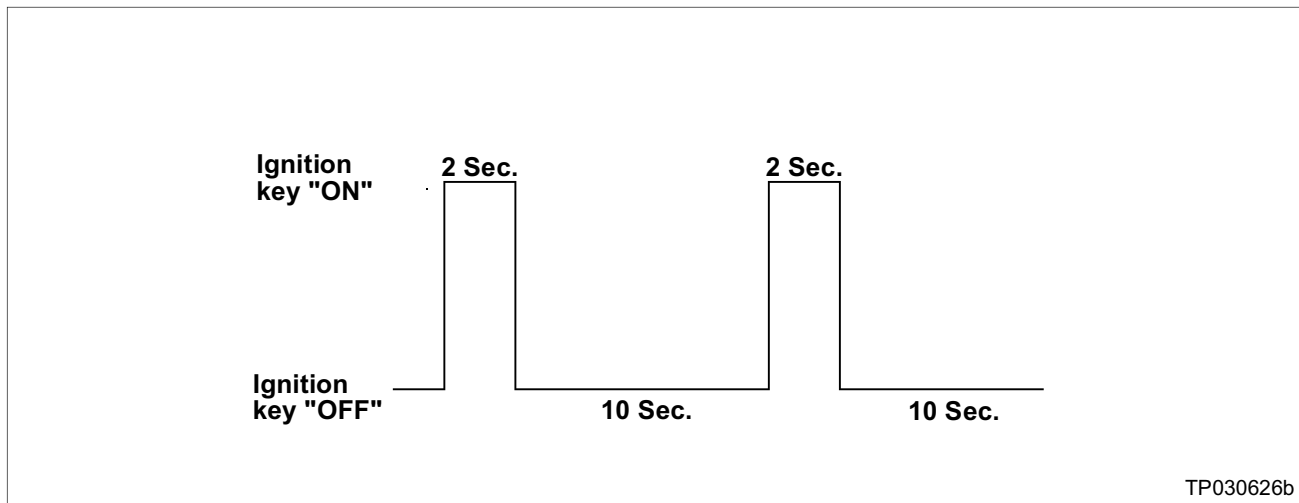
Figure E

1. Turn the ignition switch "OFF" and CONSULT-II "OFF".
 2. Wait more than 10 seconds, then;
 - a. Turn the ignition switch "ON" for 2 second, then
 - b. Turn the ignition switch "OFF" again for 10 seconds (see Figure E).
- This will reset ECM "self learned" Data.
