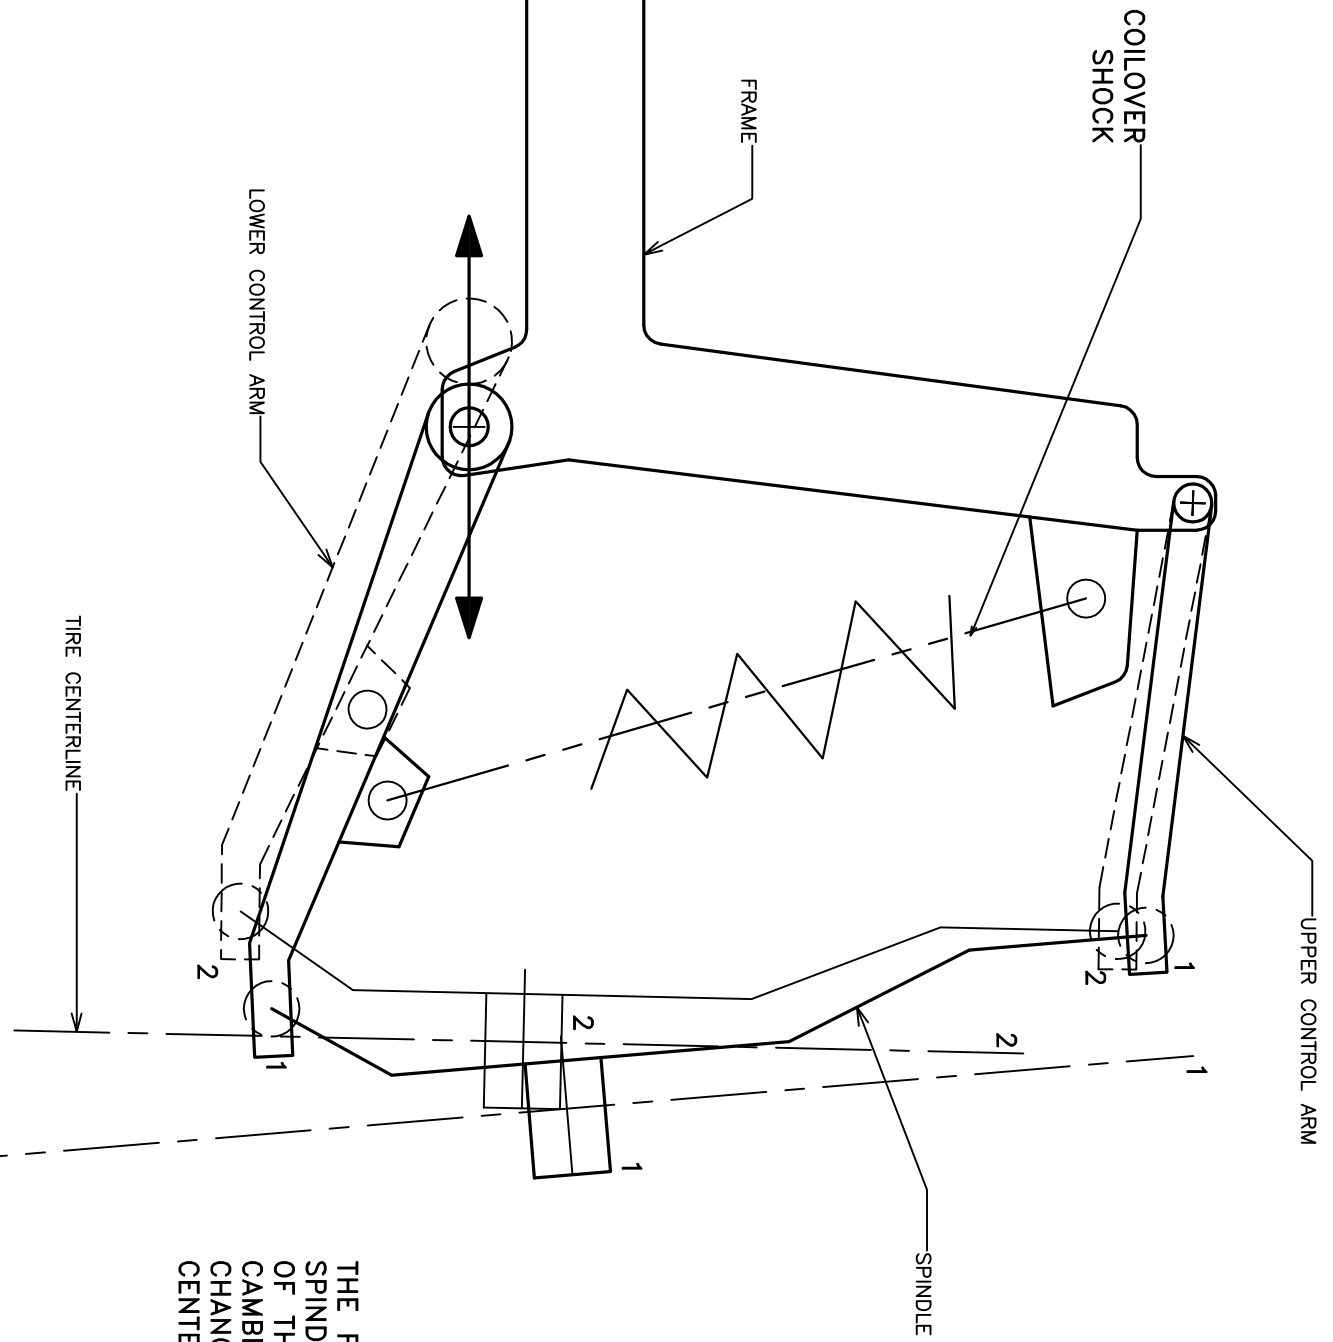
THE FRAME, UCA, COILOVER LENGTH AND SPINDLE HAVE NOT CHANGED. THE LOCATION OF THE LCA HAS CHANGED THOUGH, VIA THE CAMBER ADJUSTMENT BOLTS. NOTE THE CHANGE IN CAMBER AS SHOWN VIA THE TIRE CENTERLINES, EXAGGERATED, OBVIOUSLY.
