SERVICE BULLETIN

Classification: BT04-047	Reference: NTB05-029	Date: April 14, 2005
-----------------------------	-------------------------	-------------------------

2004 TITAN & ARMADA SQUEAK AND/OR TICK NOISE FROM FRONT SEATS

APPLIED VEHICLES: 2004 Titan (A60) with leather seats **only**.
2004 Armada (TA60) with leather seats **only**.

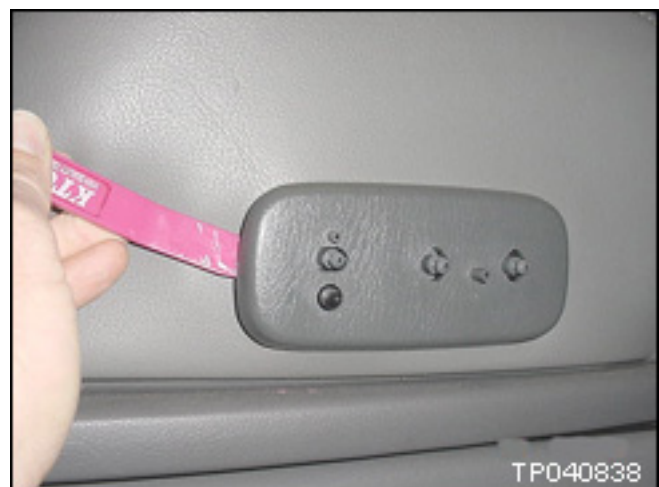
Figure 2

3. Remove the adjustment switch trim.
 - Snap it loose, releasing 4 locking tabs.
 - Use a plastic trim tool.

CAUTION: Don't damage the trim or the seat material during removal.

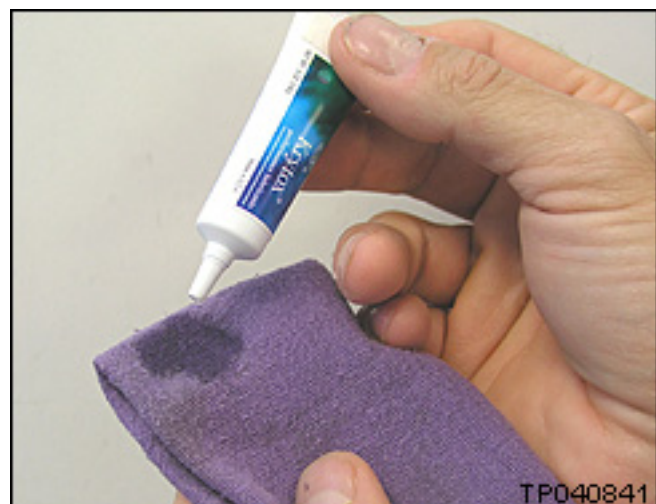
Figure 4

6. Apply a moderate amount of lubricant to the corner of a clean rag.
 - Use Dupont Krytox® lubricant GPL-105 (listed in the Parts Information) or equivalent.

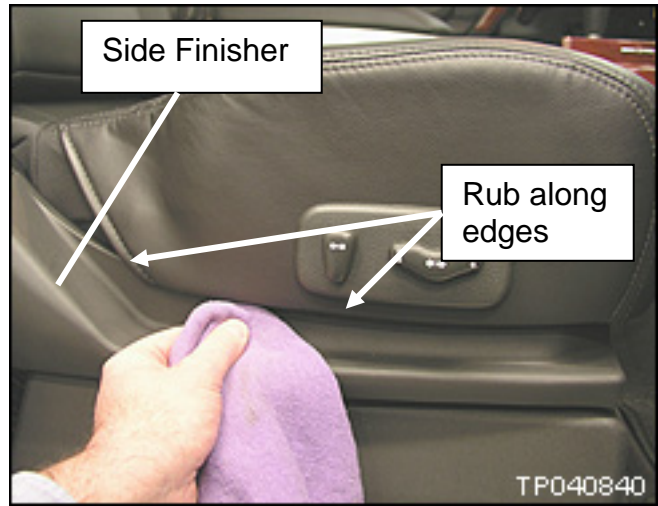
Figure 5

7. Move the power seat cushion UP using the power seat switch.
8. Apply lubricant to the lower edge of the seat cushion material.
 - Rub the rag along the edges that touch the side finisher.
 - Make sure to rub (apply) the lubricant on the inside of the edge and the bottom of the edge.
